Garyville Historic District

Design Guidelines

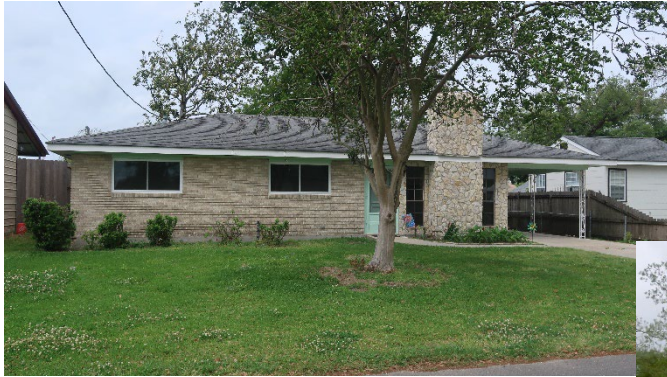
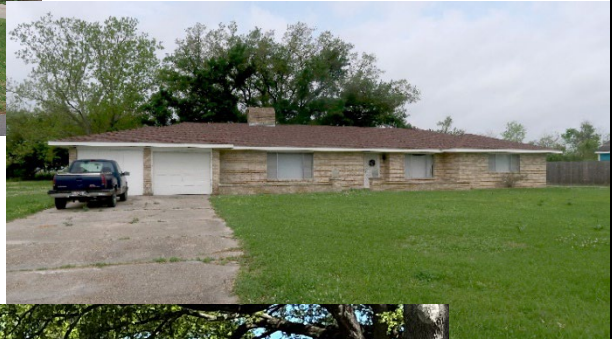
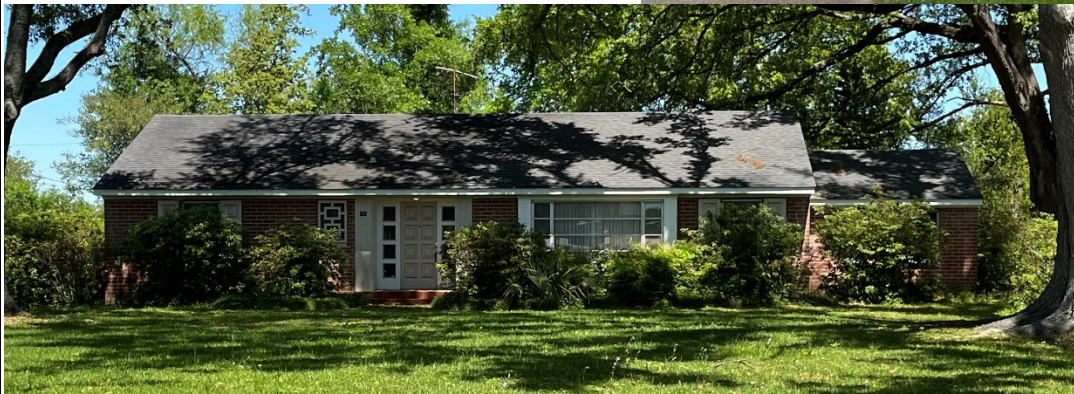
Building type: Ranch House

Ranch houses originated in California in the 1930s but spread nationwide in the 1950s and 1960s. Ranch house construction relied on standardized building materials, such as sheetrock and lumber, and methods developed during rapid construction methods developed during World War II, such as concrete slab foundations.

- 1 story height
- Concrete slab foundation
- Asymmetrical façade with strong horizontal emphasis
- Low pitched gable or hip roofs
- Garages and carports integrated into house plan

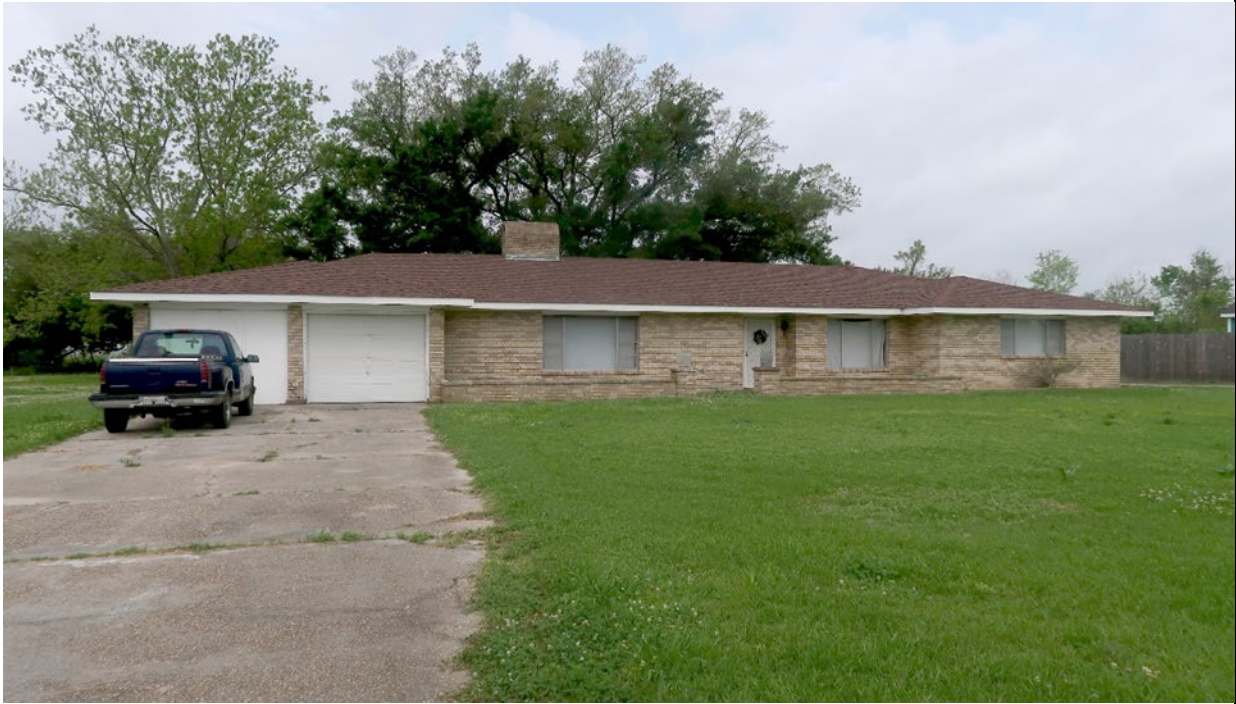
Historic architectural style: Ranch

Ranch homes became the most popular style of American home by the 1960s. Influenced by the earlier Prairie-style architecture, high style examples may have leaded or stained-glass windows, original doors with decorative glass, and heights of two stories.

- Recessed entrance with door covered by main roof.
- Double-hung or awning windows with horizontal panes.
- Picture windows, often with a single large central pane.
- Brick exteriors are common.
- Simple masonry planters integrated into facade, often near entry.
- Partial width porch.
